RAMAPO RIVER BANK EROSION INVESTIGATION

**Borough of Oakland
Bergen County, New Jersey**

Our File No. OK-1447

JULY 2011

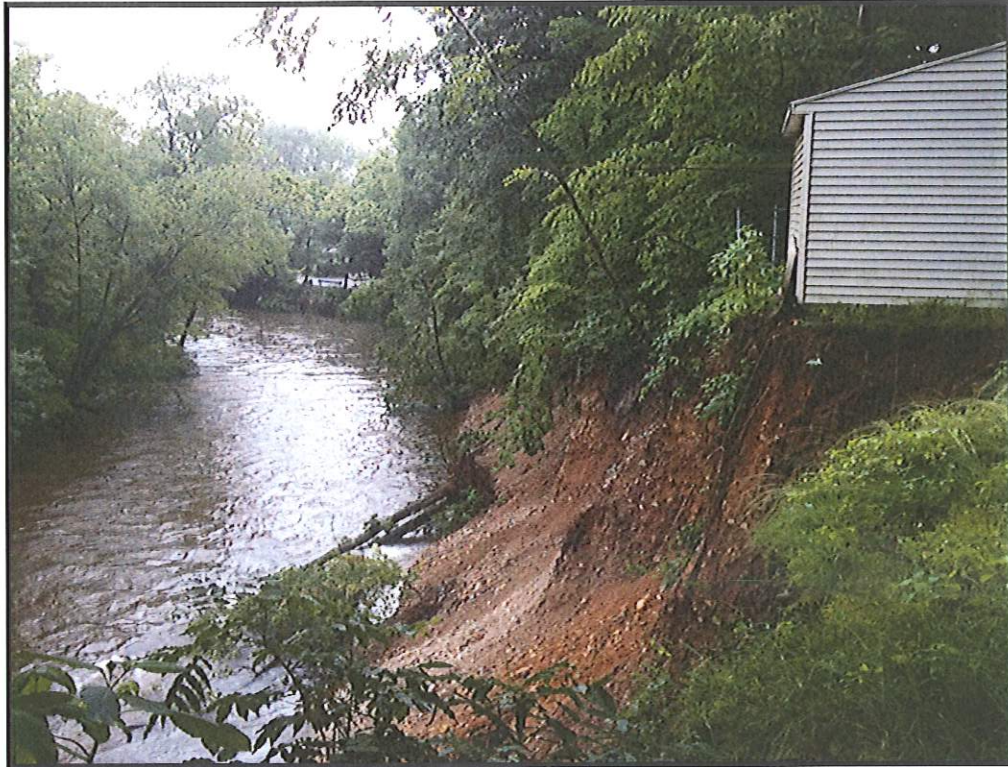
The stretch of Ramapo River, directly north of I-287 appears to have experienced higher stream velocities in recent years which have impacted the adjacent banks. In particular, the flows on the outer bank of the River have washed out the toe of the slope on the eastern bank, causing the land above to collapse. This condition has affected the rear lots of homes along Lakeshore Drive which are approximately 20 to 30 feet higher than the River. 15 Lakeshore Drive has experienced some of the most severe erosion, due to its location on the outermost point of the river bend. The erosion has impacted approximately 800 feet along that bank. There has been a continual loss of mature trees from the top of the bank during the past several years which not only has destabilized this bank further but has also introduced significant amounts of debris into the waterway. Images showing the existing conditions have been included in Appendix B for reference.

Figure 1. View of Existing Shed on Rear Lot of 15 Lakeshore Drive

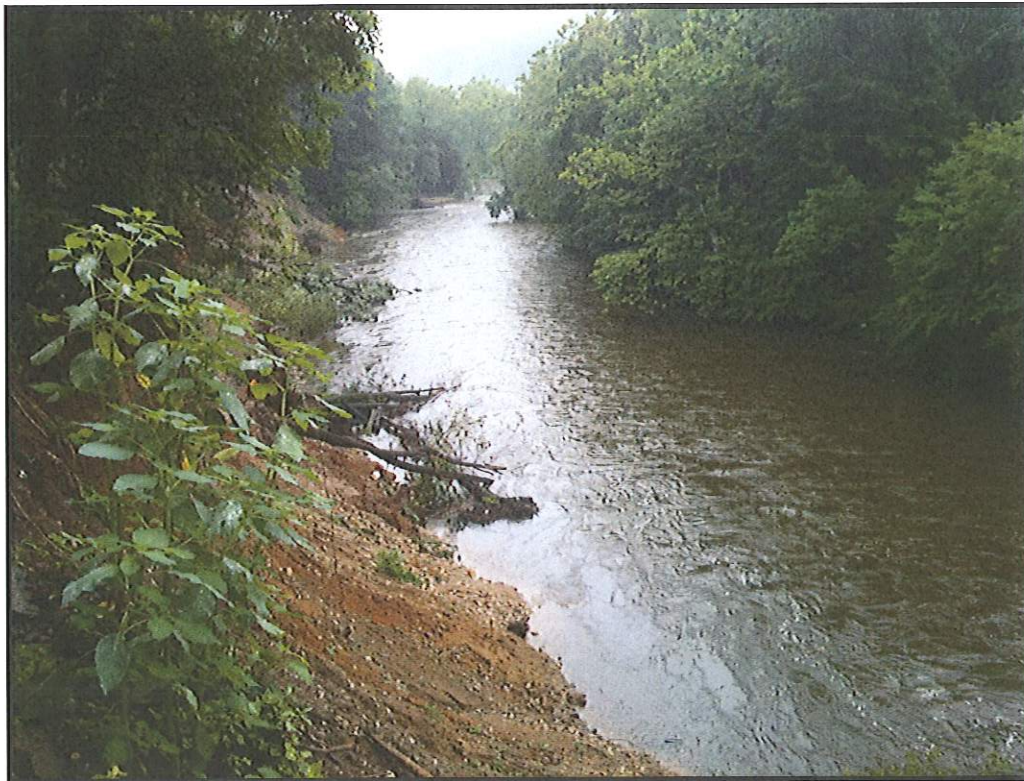
Figure 2. Downstream View of Ramapo River Stream Bank

This assessment has determined the most cost effective method to stabilize the failed stream bank condition is hammered rock stabilization at an estimated cost of \$600,000. This estimate does not include the permitting procedures which can be better determined following consultation with NJDEP.

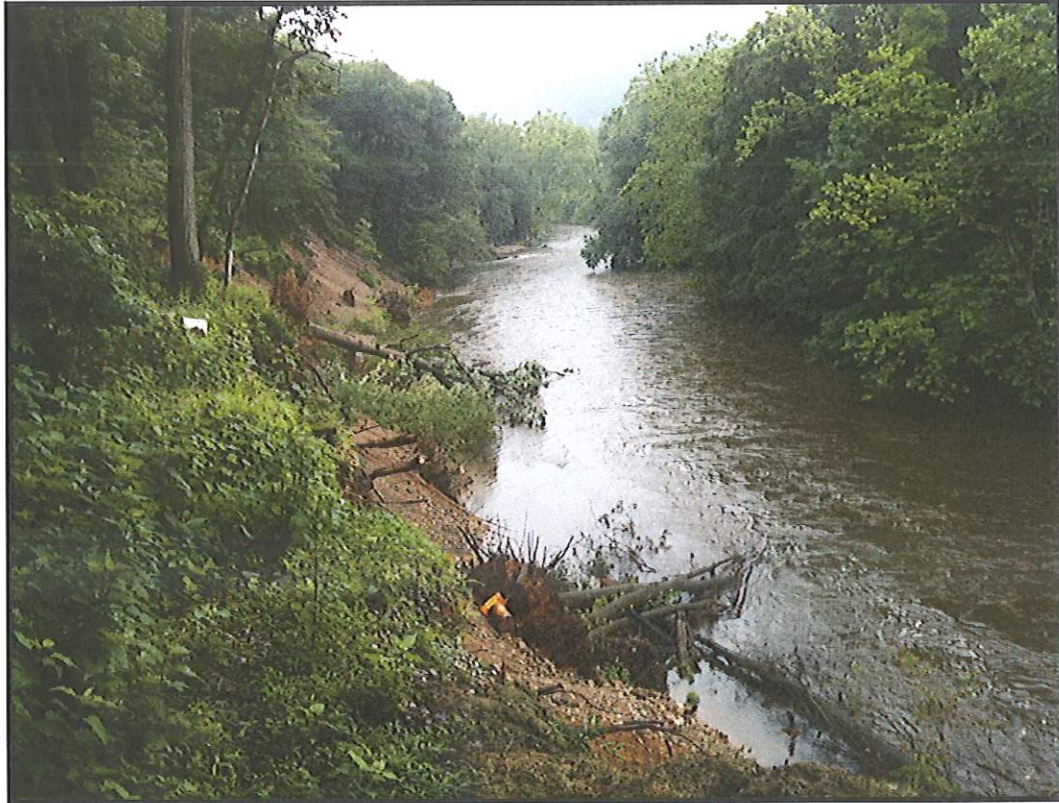
Figure 3. Additional Downstream View of Ramapo River Stream Bank

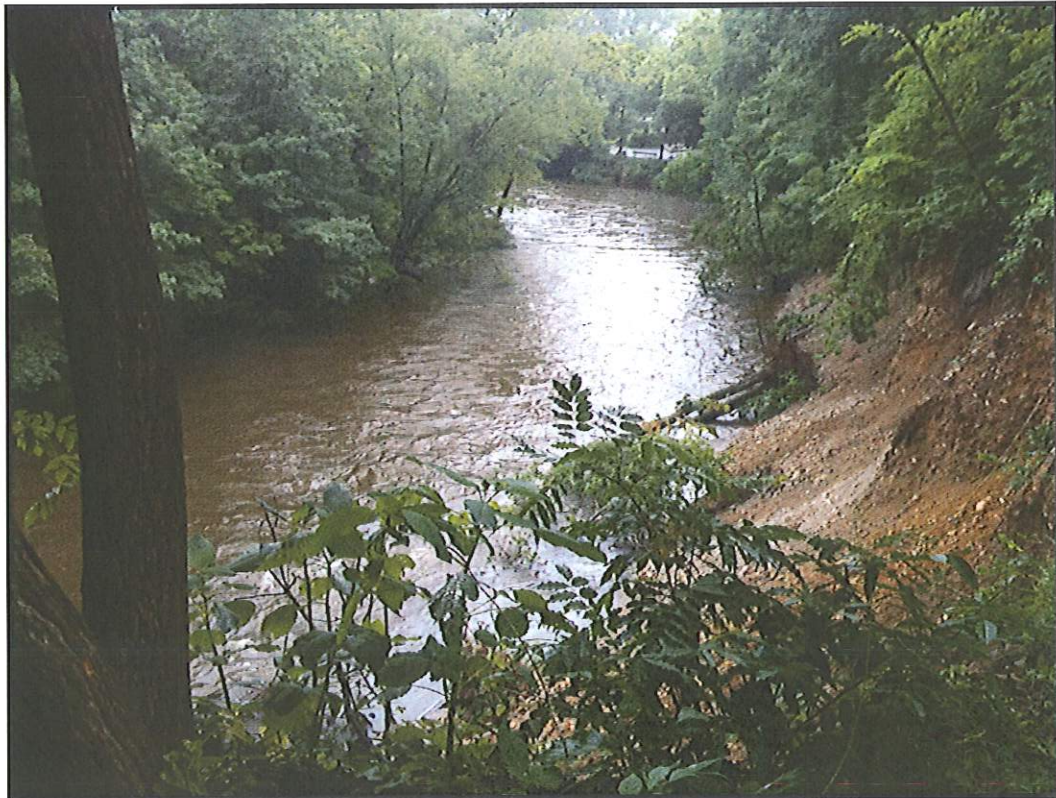
Figure 4. Upstream View of Ramapo River Stream Bank
